An Apprentice's Story

An Apprentice's Tale – Part 2

An Apprentice's Tale - part 3

An Apprentice's Tale – Part 3(a)

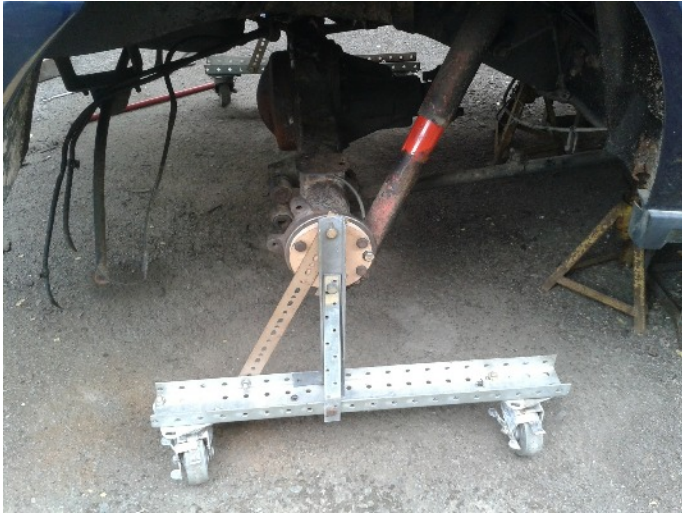
Fitters' Stock Bogies bolted to axle tube

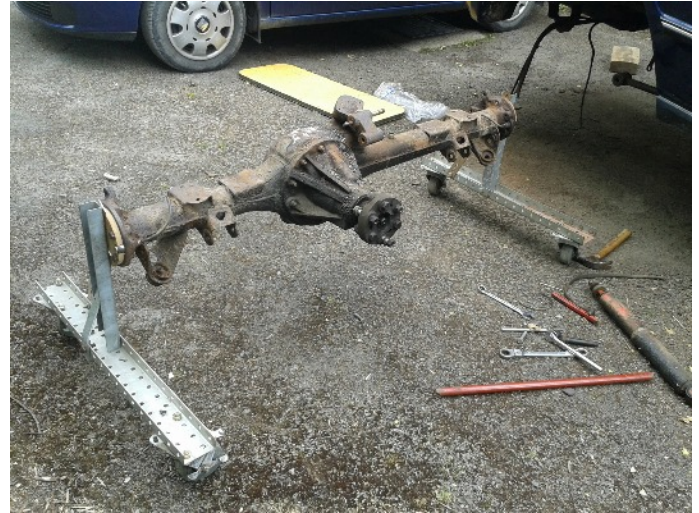
And it's out (sorry about the mess, should have cleared up before photo)

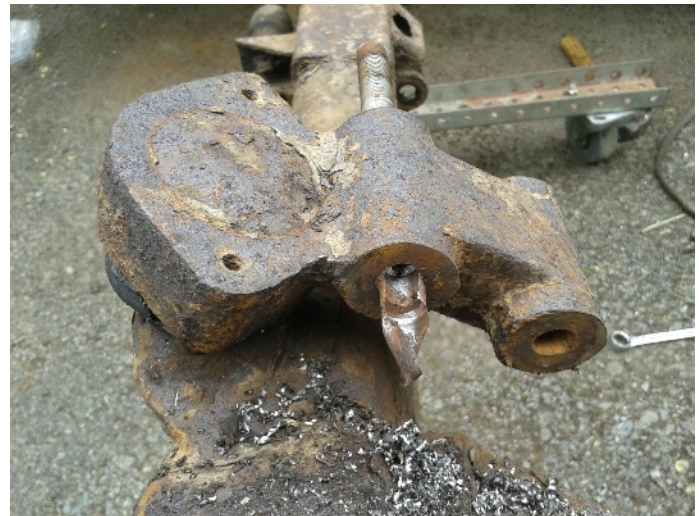
Sounds easy, doesn't it? Unfortunately, one of the through bolts securing the upper control arm ball joint casting to the arms was rusted solid, and took three days to free. This was eventually achieved by cutting the head off with a cutting disc in the angle grinder, then pilot drilling, and finally drilling out to the full 1/2" using two pistol drills, to allow one to cool off while

the other was getting overheated. Not easy whilst scrunched up underneath the car. *(Note the swarf in the picture above)*

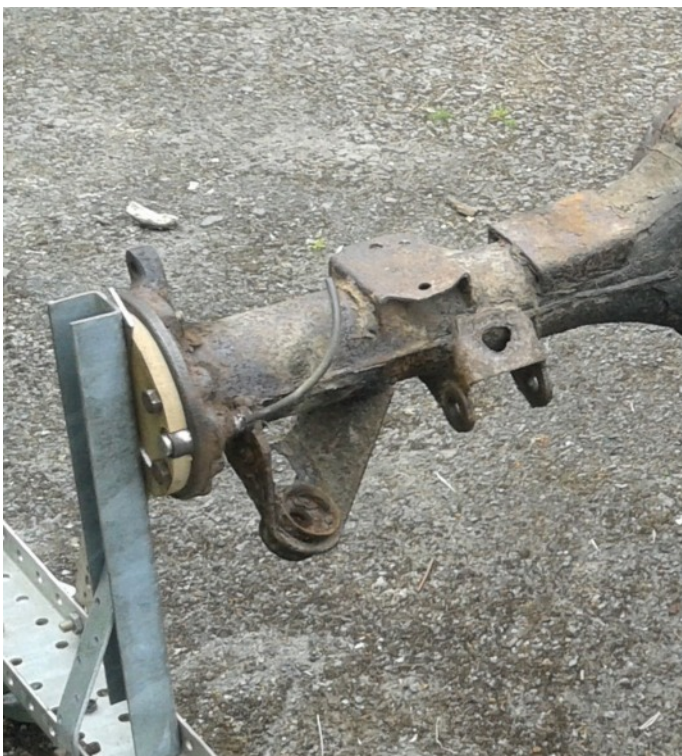
The next problem was the corroded suspension pickup points on the axle casing *(left)*. The shock absorber lower mount has huge holes where there should be metal, and the lower radius arm bracket isn't much better. Unseen from this view, the anti-roll bar mounts behind the axle were also pretty bad.

Then it was just a matter of removing the diff, cutting off the rusty brackets and preparing for the new bits to be welded on. Unfortunately, whilst wire brushing the tin rear cover on the diff, I went through it, so that had to come off as well, an additional expense I hadn't bargained for.

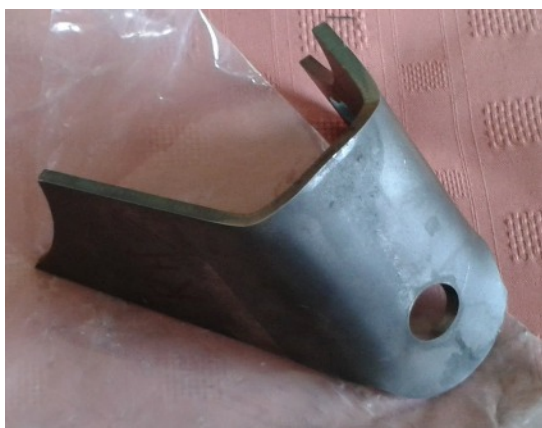
One of the new shock absorber mounts before welding on.

When all the necessary welding was finished, I took the complete axle tube assembly (less diff) to the local Monumental Mason's to have it sand blasted, then gave it a coat of Phosphoric Acid Etch Primer, and finally a couple of coats of that well known brand of smooth black paint.

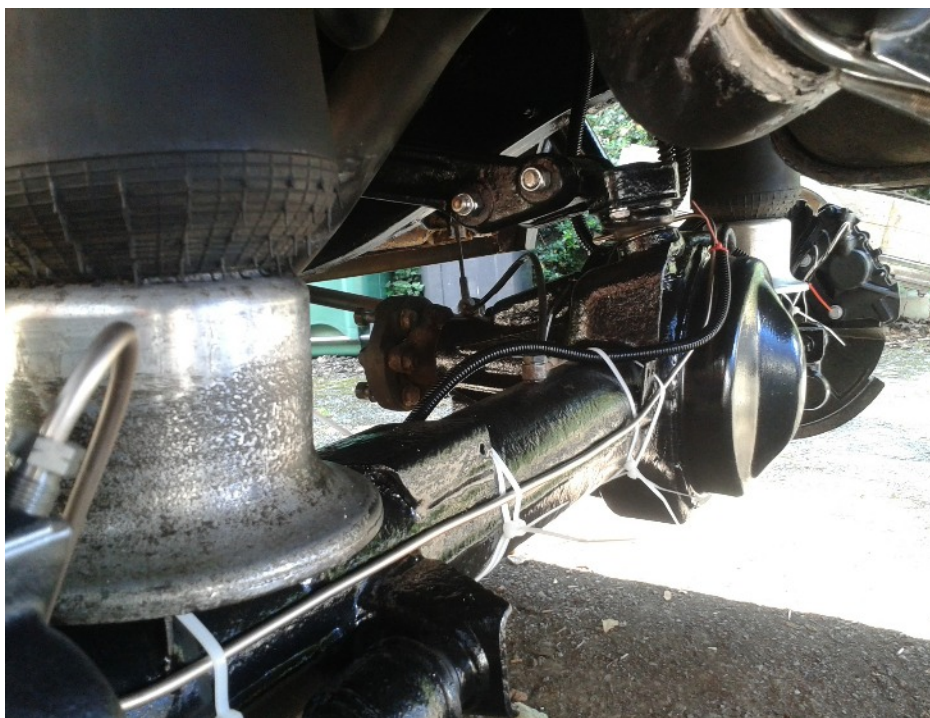
Axle painted and back in position. New brake pipes and wiring.

Of course, I had taken time to sand blast, etch, and paint the rear half of the chassis, so it all looks nice and clean and new. New discs, callipers, and brake pipes were added, and a new ABS sensor loom, because I had to destroy the old sensors to get them out, they

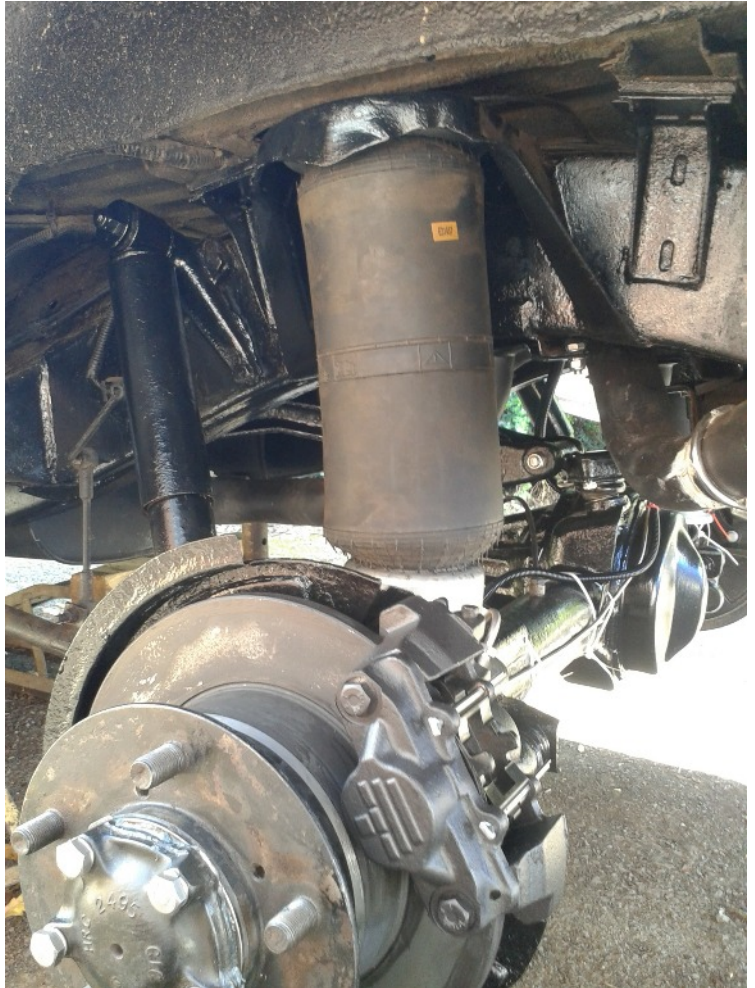
The old air springs were badly perished, although they didn't appear to leak, so I fitted a complete new set of four. Every bolt I took out was measured and discarded, to be replaced by a stainless steel equivalent. Almost the only exceptions to this were the four special 12 point, fine thread, M12 x 1.25 bolts attaching the callipers, I haven't yet found a source of supply for them, but I will later. The upper ball joint nut was another impossible find.

Showing new discs and callipers, new air springs and refurbished shocks.

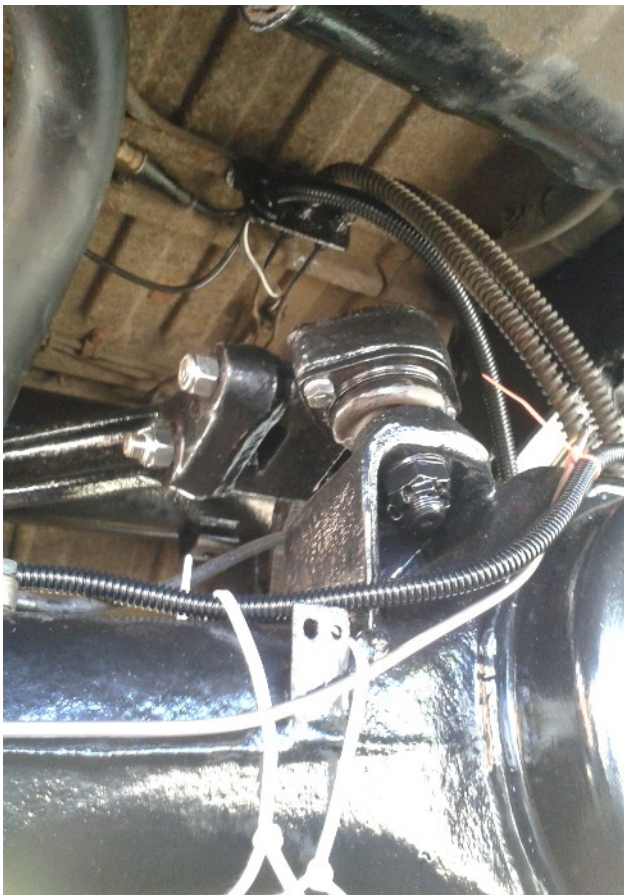
Top Ball Joint. Unfortunately, not a stainless nut as it also has a funny thread.

The new top ball joint was pressed back into the casting by a local truck maintenance firm, my 6 ton hydraulic press was nowhere near powerful enough to do the job, it took 25 tons to get it seated. As mentioned previously, the taper joint also has a stupid thread, M22 x 1.5 in this case, so I couldn't get a stainless replacement, hope the layers of paint are sufficient to preserve it. The two 6½ inch long ½" UNF through bolts attaching the ball joint casting to the two upper control arms had to be made by threading two 7" lengths of ½" diameter stainless steel round bar at both ends and fitting two Nyloc nuts on each, as seen in the photo.

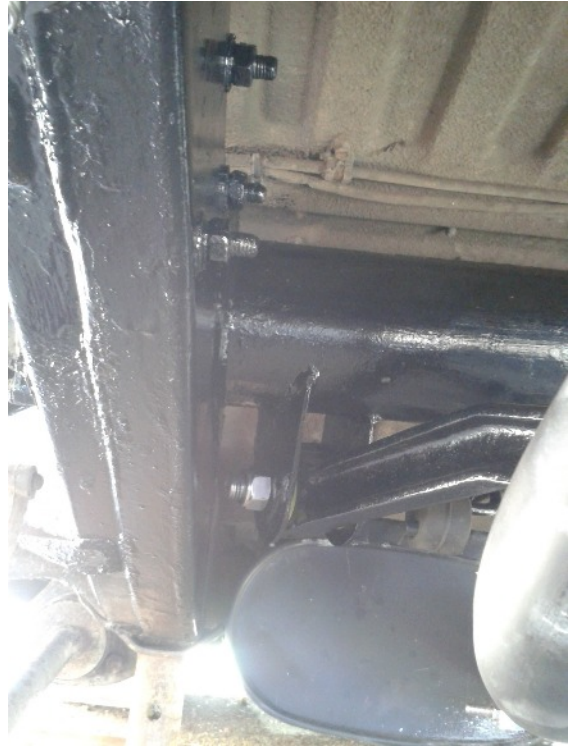
Upper control arm to chassis mount

I had a bit of fun with the Upper Control Arms, I removed the old Metalastic bushes and fitted new Polybushes. As the original pivot bolts had had to be cut out using a cutting disc in the angle grinder, I fitted new stainless steel bolts in their place. Unfortunately, I couldn't get $\frac{3}{4}$ " UNF stainless bolts, so 20mm would have to do. This meant opening up the holes in the chassis brackets, so a 20mm cone drill was used to enlarge them and keep them concentric. I also replaced the plated steel $\frac{3}{4}$ " bore centre tubes of the Polybushes with stainless steel ones with a 20mm inside diameter.

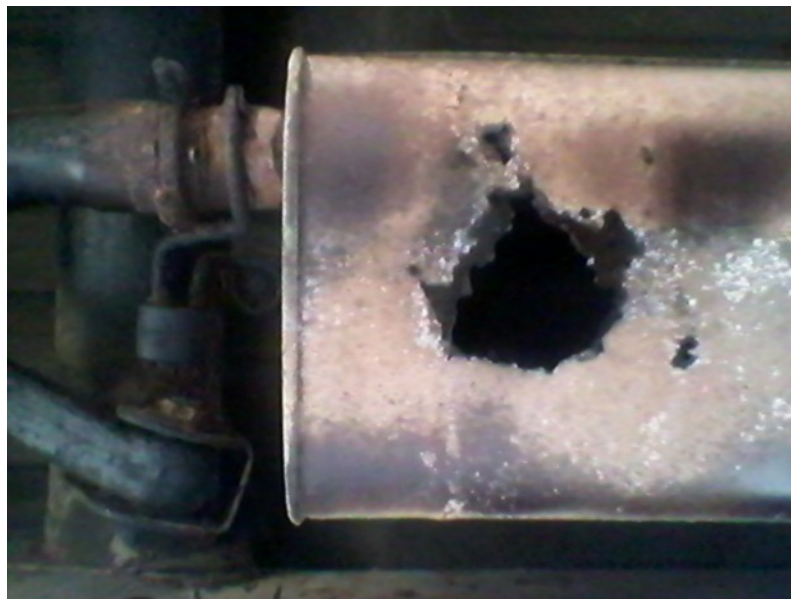
Holey silencer, no wonder she was noisy

the old one was more holey than righteous, and removing the silencer resulted in the destruction of just about all of the rest of the old system.

While she was up in the air, I fitted a new exhaust system, because

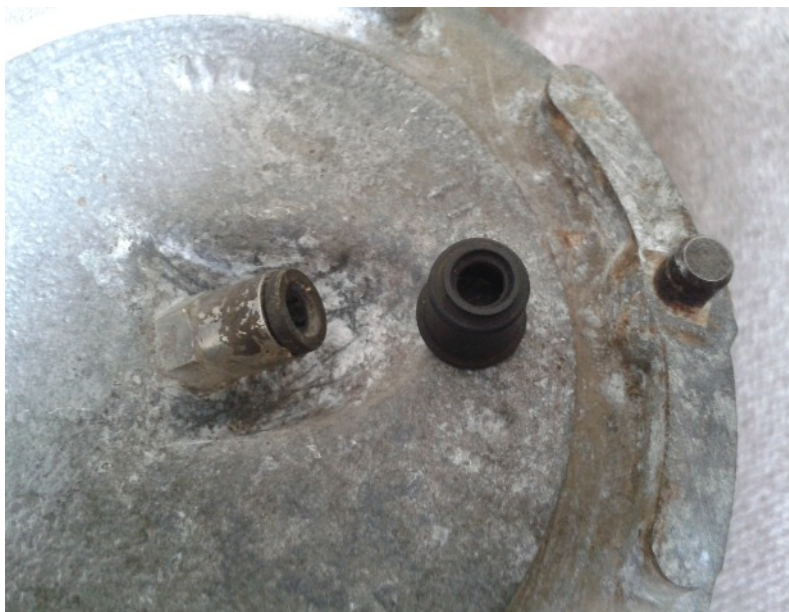
When it came to disconnecting the old air springs, the text in the workshop manual mentions peeling back the rubber boot and depressing the collet to allow the air pipe to be removed, then replacing it after the new connection is made. The illustration also shows this rubber boot, but they were both missing from the rear springs on this car, so the collets were jammed up with road dirt and impossible to depress. This meant that I had to cut the pipes as close to the collets as possible, then remove the pipe fitting and clean it out, so that I could extract the stub end of the pipe and refit the slightly shortened pipe. The Parts Manual, however, does not show or list these rubber boots, so I took the ones from the front springs to put on the back, because the front springs are not exposed to road dirt in the same way as the rear, and therefore not subject to getting bunged up. I have since determined that they are actually valve stem oil seals, but I don't know what engine they are from (yet).

The elusive rubber boot/valve stem oil seal on top of the rear air spring

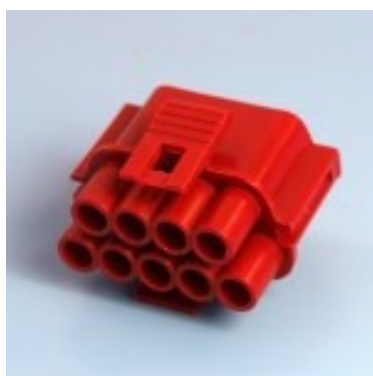
9 way TTS shell

The TTS shell had to be cut between the first and second, and between the third and fourth sockets on the top row, which resulted in the second and fourth sockets on the bottom row being cut in half. It also meant that the spring latches were on the discarded centre portion, but as it only has to stay in place whilst being used to reprogram the ECU, that's not really important. Gluing the two outer halves together, and binding with twine before impregnating the twine with Superglue resulted in a robust assembly, ready to be populated with the necessary contact sleeves.

Of course, in order to connect the laptop to the air suspension ECU, I had to make up a special cable, but the five way Rist's TTS plug is no longer available. After a bit of head scratching, I bought a 9 way TTS plug, cut it into three pieces, discarded the middle part, and glued the two outer parts together to form a new 5 way plug. The serial port plug on the other end of the cable has to have a couple of electronic components inside the shell to interface the laptop with the suspension ECU.
