An Apprentice's Story

An Apprentice's Tale – Part 2

An Apprentice's Tale - part 3

An Apprentice's Tale – Part 3(a)

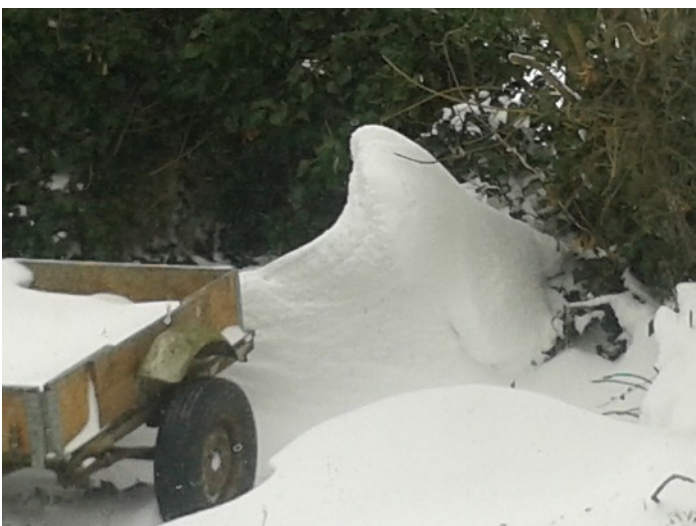
The scale model of the Matterhorn – courtesy of the Beast from the East.

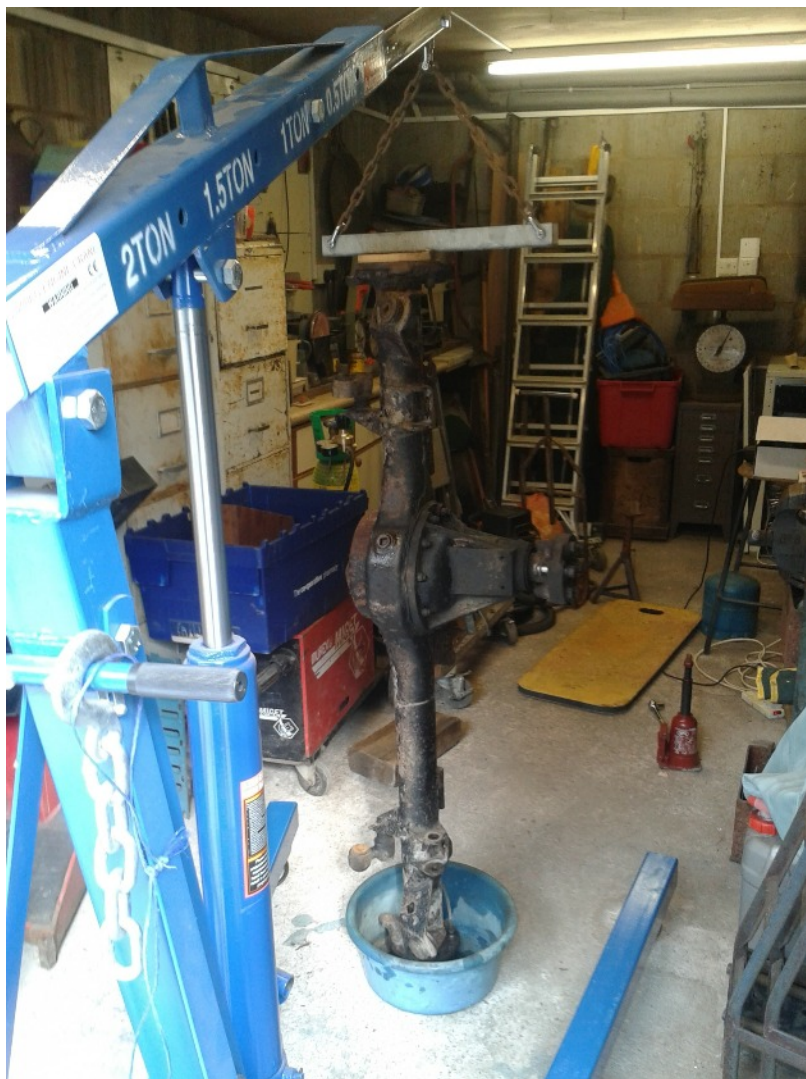
One of the new shock absorber mounts before welding on.

When all the necessary welding was finished, I took the complete axle tube assembly (less diff) to the local Monumental Mason's to have it sand blasted, then gave it a coat of Phosphoric Acid Etch Primer, and finally a couple of coats of that well known brand of smooth black paint.

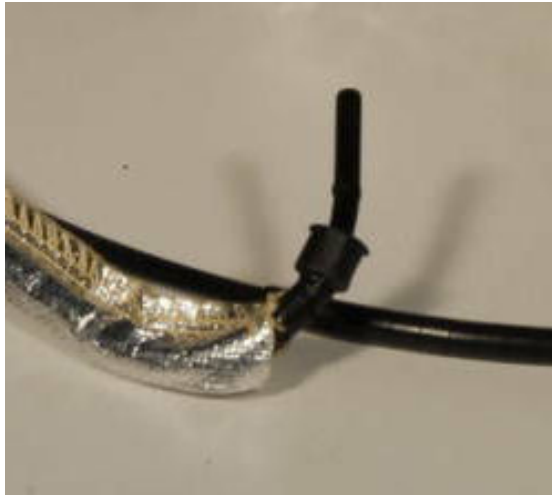
As you can see, each of the air pipes (in the picture at left), is supplied complete with its own dust cover, so they do not need a separate part number. The corollary of this is that in order to purchase a replacement dust cover, one is forced to shell out for a complete pipe assembly. I looked up the price of the front pipe (ANR1740), it is £44.95 +VAT.

This dust cover, made by Camozzi, is actually supplied by Parkair to fit on the push fit pipe connectors from the same company, which is what is used by Land Rover on the top of each of their air suspension units.
